IMO

A 20/Res.866
29 December 1997
Original: ENGLISH

RESOLUTION A.866(20)
adopted on 27 November 1997

**GUIDANCE TO SHIPS' CREWS AND TERMINAL PERSONNEL FOR BULK
CARRIER INSPECTIONS**

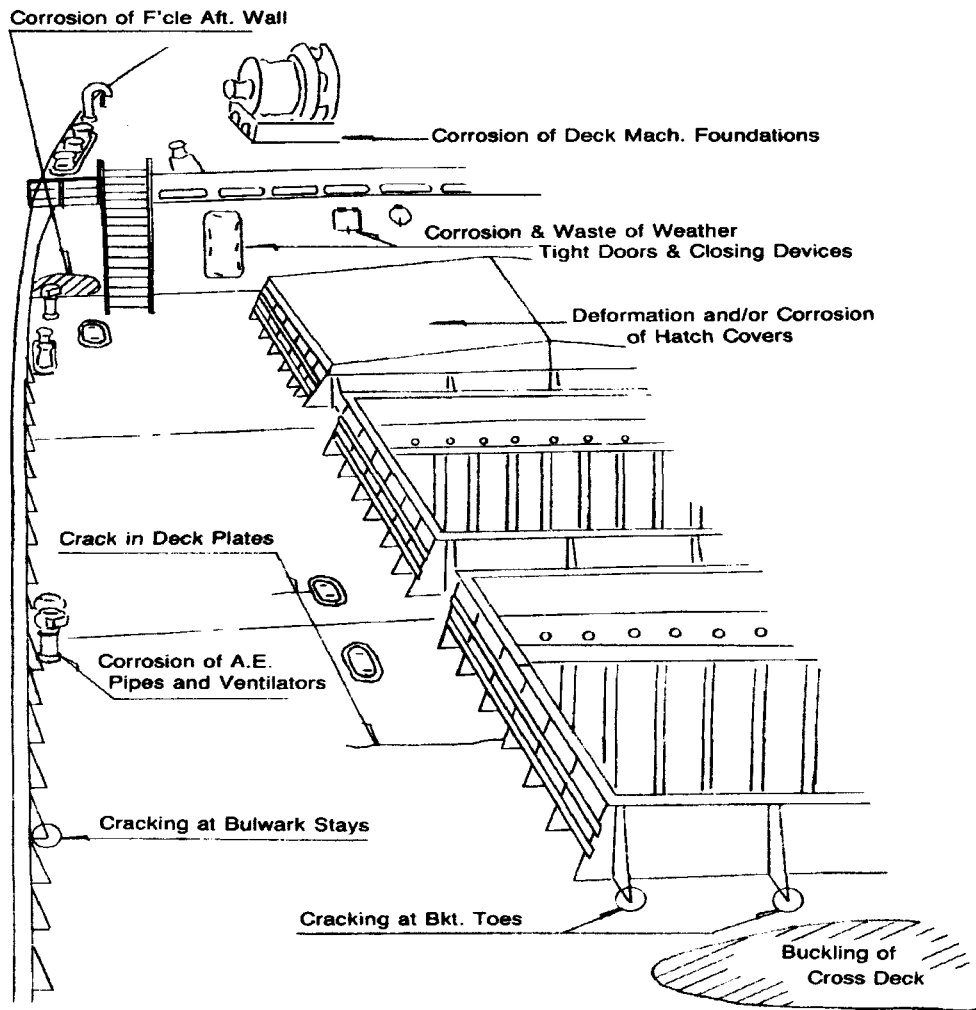
Figure 4: Check points on the upper deck

6.1.2 Bulk carriers have cargo hatchways for the convenience of cargo handling facilities. These hatchways reduce the ship's torsional strength and invite concentrated stress at the hatchway corners which may be evident by cracking of the deck plates in these areas.

6.1.3 Cross deck strips come under stress by transverse bending. The transverse bulkheads provide transverse strength to a bulk carrier and the cross deck strips provide the strength to withstand the resultant axial forces in a transverse direction.

Buckling of cross deck strips

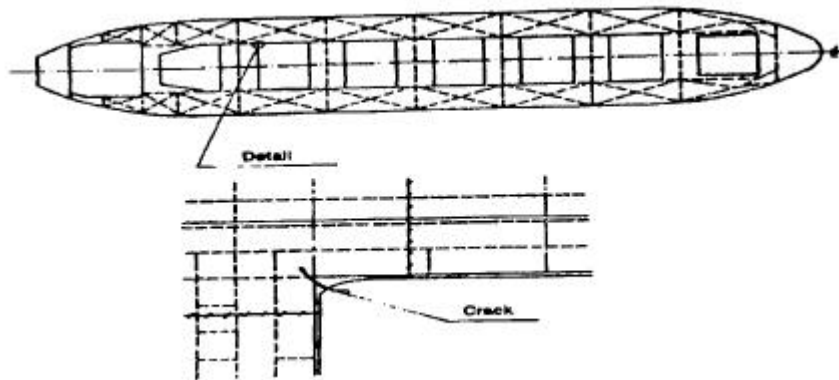
Figure 6: Cracking at hatchway

The large cargo hatchway openings reduce the torsional strength of the hull and invite stress concentration at their corners on the upper deck. In this regard, upper deck plating at hatchway corners is one of the focal points for cracking. Particular attention should be paid to these areas during inspection.

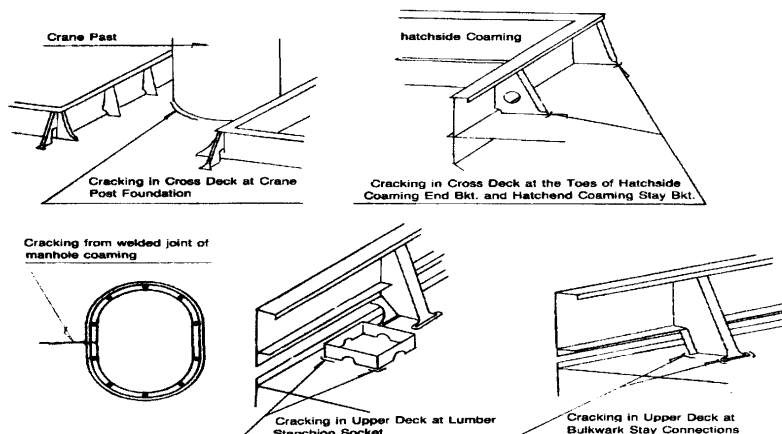
Figure 7: Various crackings in upper deck plating

Various metal fittings are welded to the upper deck plating. These installations may cause stress concentrations at the welded joints or have defects in the welds. Deck platings in the vicinity of manholes, hatchside coaming end brackets, bulwark stays, crane post foundations and deck houses, etc. are to be carefully watched for cracking.

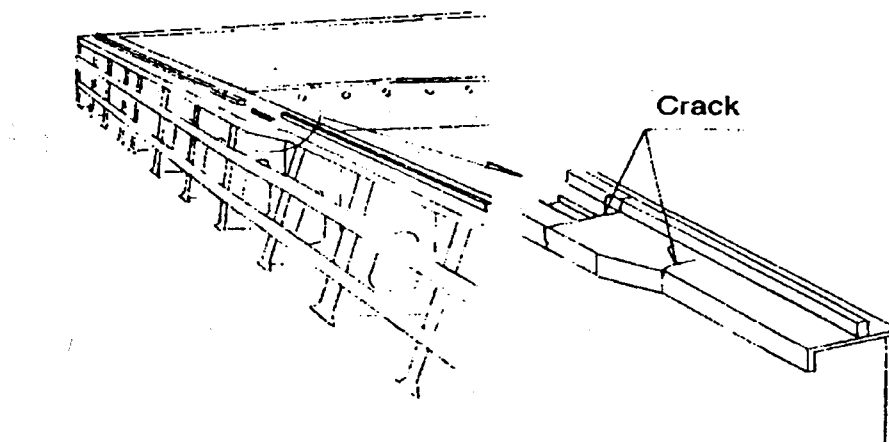
Figure 8: Cracking in hatch coaming

Hatch coamings are subjected to hull girder stress. Although they are not critical longitudinal strength members, they should be watched carefully to ensure that these cracks do not spread. Cracking may be initiated at defects in welded joints and metal fittings to the coamings that will invite stress concentration. Such cracking is considered serious to the ship's safety because it may be the initiation of a fracture on a large scale.

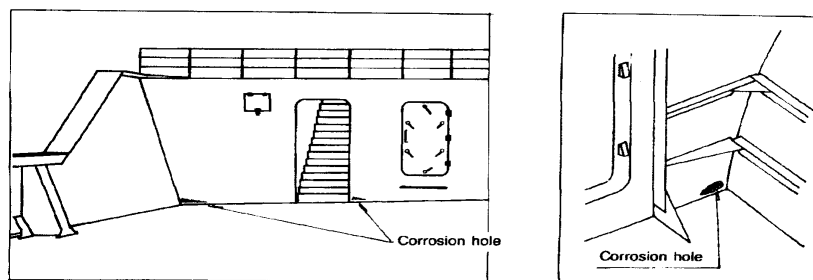
Figure 10: Forecastle end bulkhead

The bilges in fore-castle space may cause corrosion of the bulkhead where it meets the deck. In flush decked bulk carriers, the boatswain store aft wall may be corroded in the same manner. Large bulk carriers generally do not have fore-castle and have their boatswain stores down below the upper deck in fore-peak spaces. Bilges left in such spaces also cause corrosion of the aft end bulkheads which separates boatswain store and No.1 cargo hold. Such wastage may lead to water ingress, cargo damage, cargo shifting, and/or stability problems.

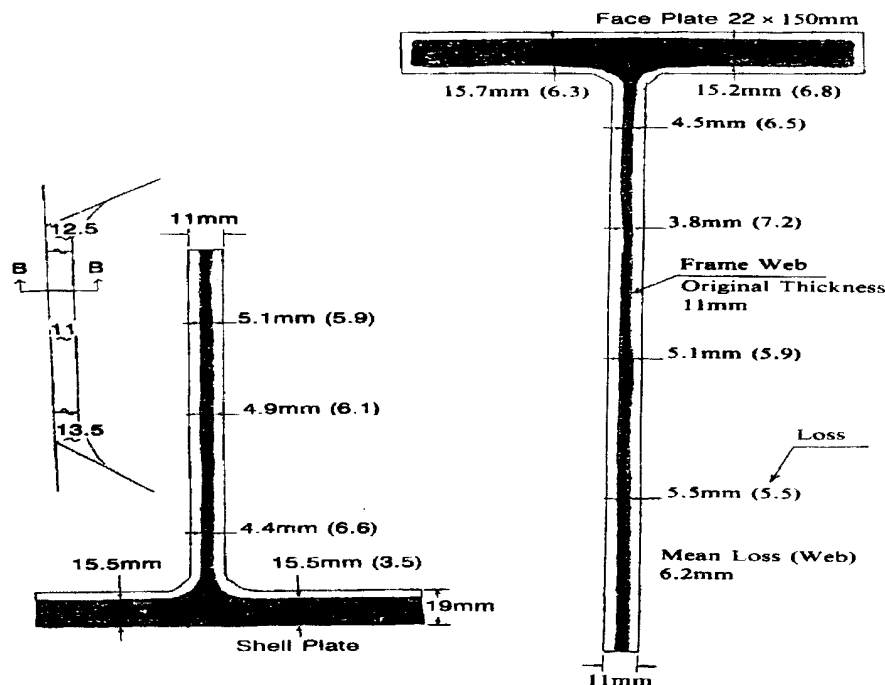
Figure 12: An example of a corroded hold frame

6.2.3 Among the various members composing cargo hold structures, the hold frames are usually the thinnest structures, especially at the web plates. In addition, the hold frames also have more surface area exposed, in that both surfaces of the plate are susceptible.

6.2.4 This may mean accelerated corrosion in the hold frames, the thinnest among all the members in cargo holds. If corrosion and waste become excessive, failure of hold frames invites additional loads to the adjacent ones, which may lead to failure throughout the side shell structure.

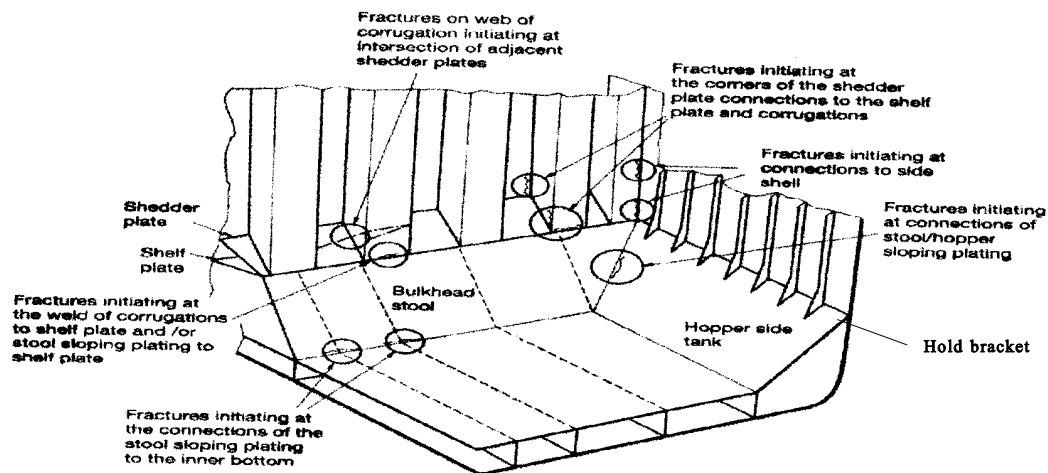
Figure 13: Typical fracturing at the connection of transverse bulkhead structure

- .1 *Fractures* at the boundaries of corrugations and bulkhead stools, particularly in way of shelf plates, shredder plates, deck, inner bottom, etc.
- .2 *Buckling* of the plating/corrugations, leading to the failure and collapse of the bulkhead under water pressure in an emergency situation.
- .3 *Excessive wastage/corrosion*, in particular at the midheight and bottom of bulkheads, which may look in deceptively good condition. This is created by the corrosive effect of cargo and environment, in particular when the structure is not coated. In this respect

- .3.1 bulkhead plating adjacent to the shell plating;
- .3.2 bulkhead trunks which form part of the venting, filling and discharging arrangements between the topside tanks and the hopper tanks;
- .3.3 bulkhead plating and weld connections to the lower/upper stool shelf plates;
- .3.4 weld connections of stool plating to the lower/upper stool shelf plates and inner bottom;
- .3.5 in way of weld connections to topside tanks and hopper tanks;
- .3.6 any areas where coatings have broken down and there is evidence of corrosion or wastage. It is recommended that random thickness determination be taken to establish the level of diminution; and
- .3.7 other structures, e.g., diaphragms inside the stools, particularly at their upper and lower weld connections.

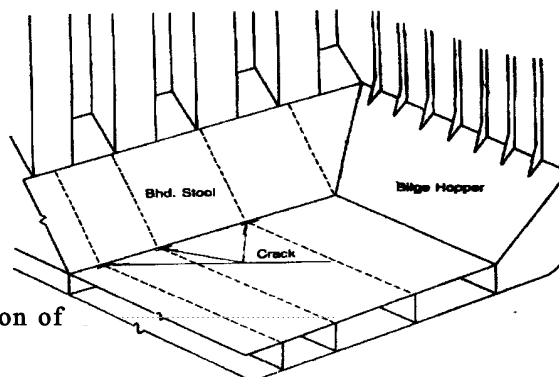
Figure 14: Cracking at the connection of bulkhead stool and tanktop

In bulk carriers having combination cargo/ballast holds, cracks may often be found at or near the connection of the stool of the transverse bulkhead and the tank top.

All capesize and panamax bulk carriers and some handy bulkers have combination cargo/ballast hold(s) to keep the necessary draught. The bulkhead boundaries of the spaces are designed to comply with the requirements for deep tank bulkheads. In these holds cracks may often be found at the connection between the transverse bulkhead and the tanktop. These cracks can be detected by visual inspection or by noting leakage from the double bottom tanks.

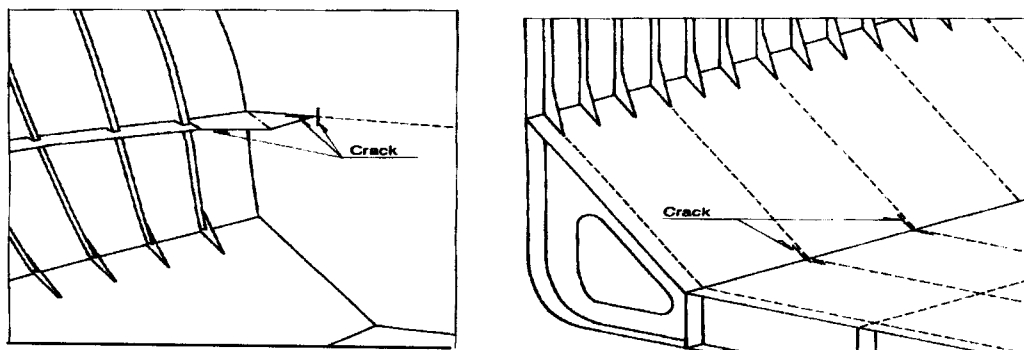
Figure 15: Cracking around the collision bulkhead **Figure 16: Cracking in bilge hopper**

Side stringers and/or side shells in way of No.1 cargo hold along the collision bulkhead are often found cracked. This kind of damage is considered to be caused by insufficient continuity between fore peak construction and cargo hold structure.

On large bulk carriers such as capesize and panamax bulkers, bilge hopper plating around the knuckle line may be cracked along the bilge hopper transverse webs. This is considered to be caused by insufficient local reinforcement.

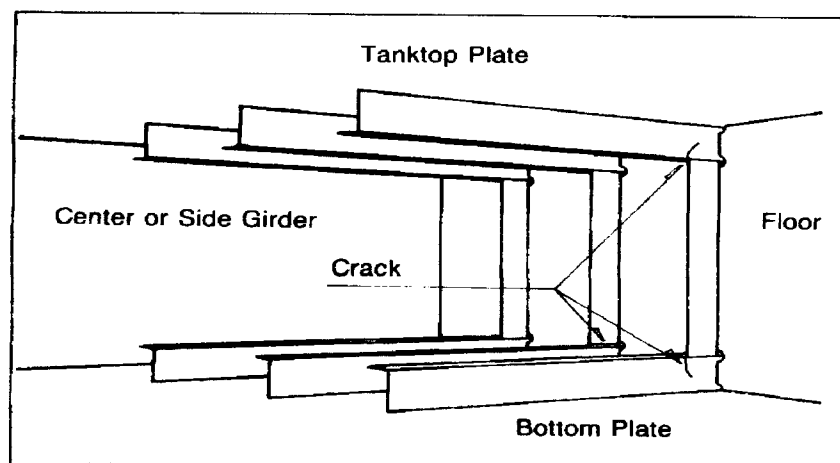
Figure 17: Cracking in tanktop/bottom longitudinals

Cracks may be found in the side, bottom and/or tanktop longitudinals at intersections with solid floors or bilge hopper transverses. Cracks also may be found in the floors or transverses occurring at the corners of the slots cut for longitudinals.

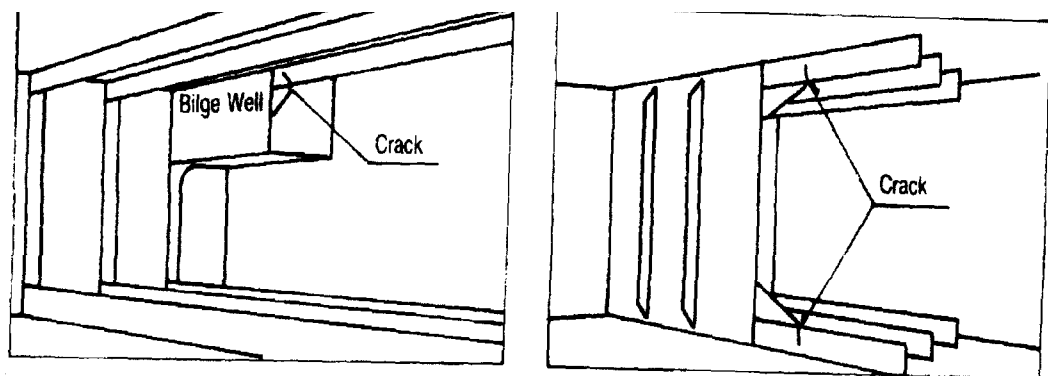
Figure 18: Cracking at the end connectionCracking at the end of an additional with side walls of bilge well girder

Longitudinals may be cracked at the ends of additional (partial) side girders provided in the double bottom below cargo hold bulkheads or at the side walls of bilge wells for cargo holds, due to additional stress concentration caused by the structural discontinuity at those connections.

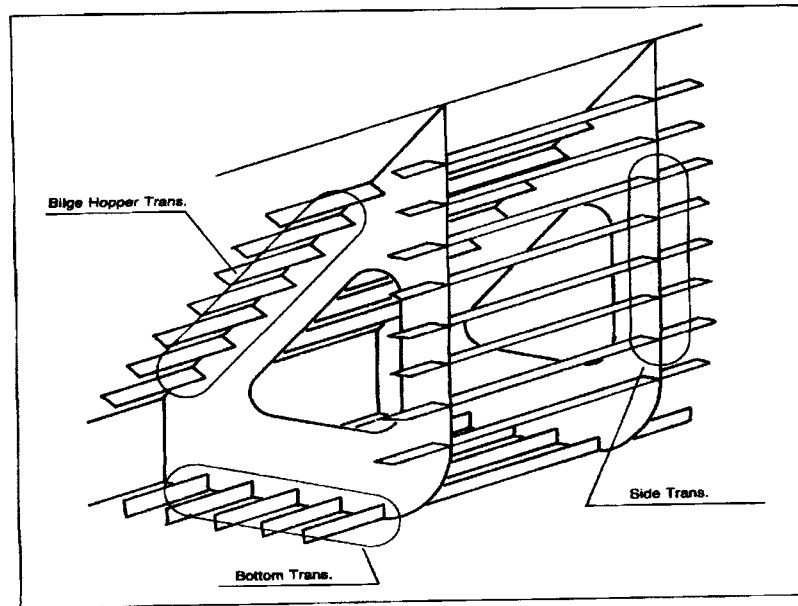
Figure 19: Check points in bilge hopper transverse

Cracks may be observed in transverse webs in bilge hoppers initiating from the slot openings for longitudinals and at the knuckled corners of the lower ends of the hoppers.

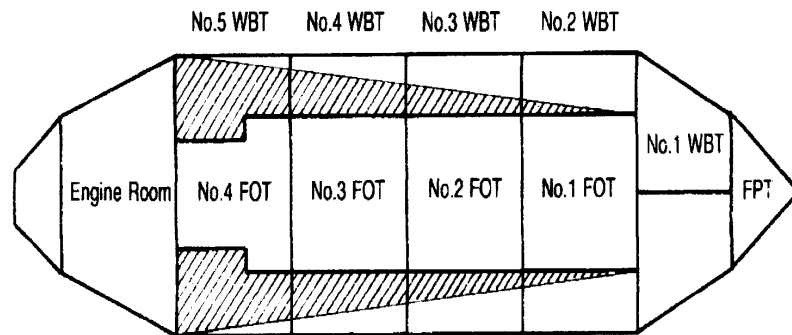
Figure 20: Areas where heavy corrosion due to heat effect may be found (hatched areas)

Since the late '70s, problems with heavy corrosion in double bottom water ballast tanks adjacent to fuel oil tanks have appeared. In some cases, the corrosion was worse in areas closer to the fuel oil tank boundaries. In those ships, fuel oil tanks were installed.

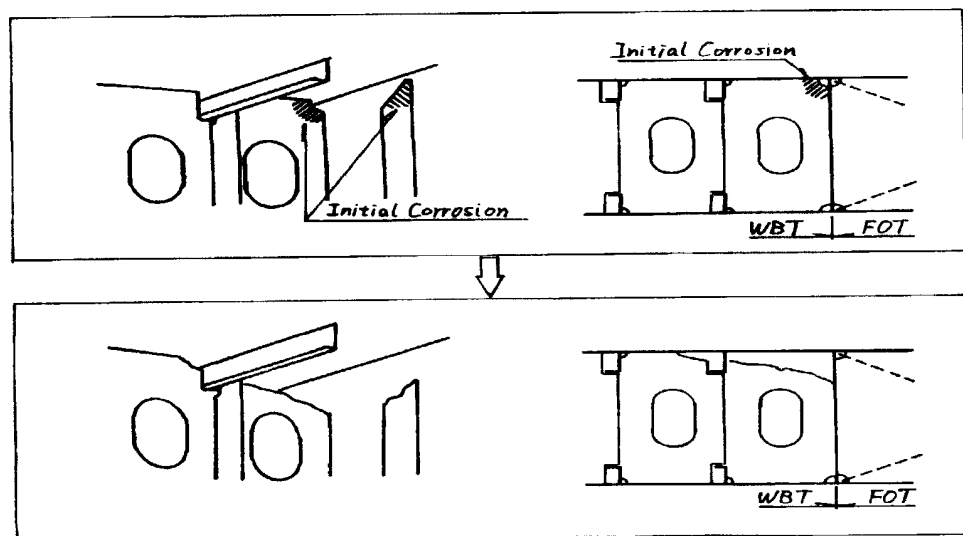
Figure 21: Progress of corrosion in water ballast tanks adjacent to fuel oil tanks (FOT)

The fuel oil heating system was adopted following changes to the properties of fuel oil, mainly an increase in viscosity. For economic reasons, ship operators began to use low grade bunker oil which needs heating in order to decrease the viscosity. At the beginning of this trend, the temperature required in the fuel oil tanks was not high enough to accelerate the corrosion of the steel in the adjacent spaces. However, in recent years, the grade of bunker oil being used requires the temperature in the tank to be 80°C or more. Such a temperature can accelerate corrosion of the steel in the tanks, particularly in the vicinity of the boundaries of the fuel oil tanks.

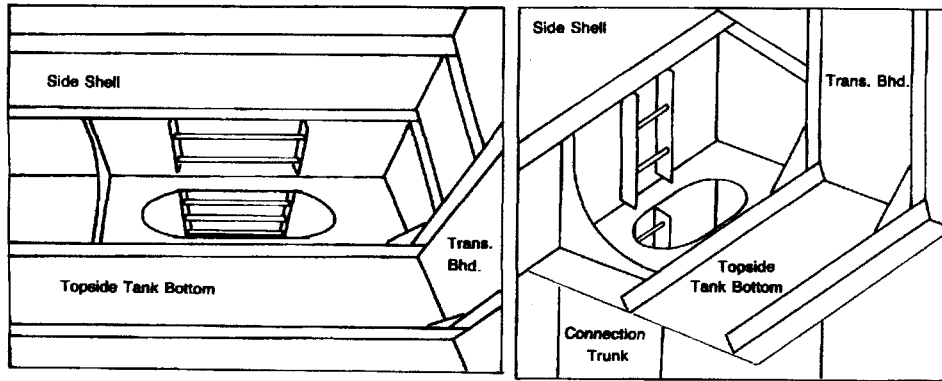
Figure 22: Connection trunk entrance in topside tank

6.5.2 Connection trunks provided between topside and bilge hopper spaces are to be carefully watched for signs of corrosion and waste of the steel works inside.

trunk spaces. The inside surface of a connection trunk is liable to corrosion and should be examined carefully.
