MSC/Circ.1117
24 June 2004

GUIDANCE FOR CHECKING THE STRUCTURE OF BULK CARRIERS

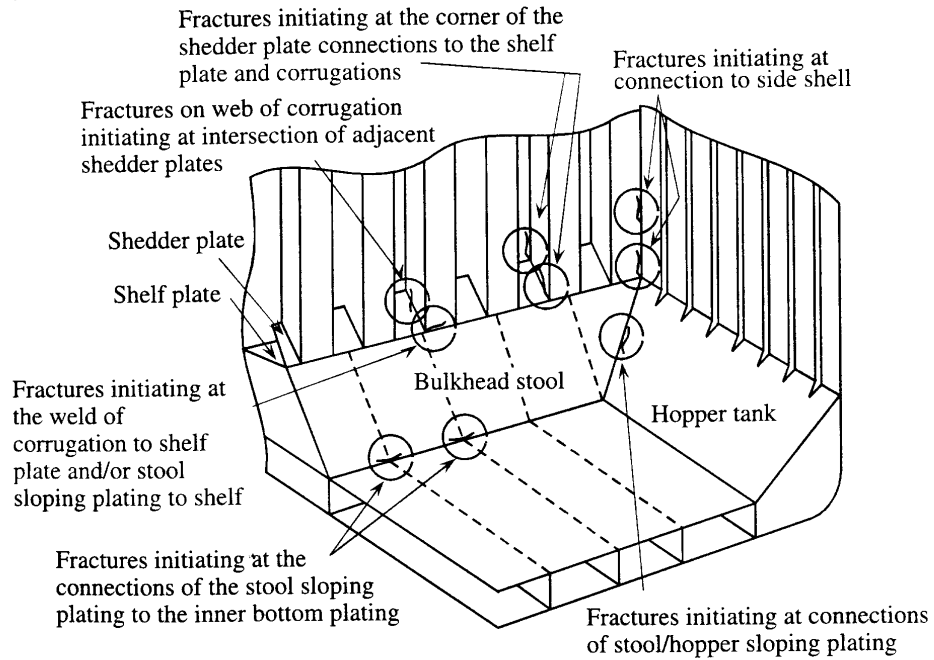
(Note: Similar damages may occur at the upper connections of the bulkhead to the deck structure)

Typical fracturing at the connection of a transverse bulkhead structure

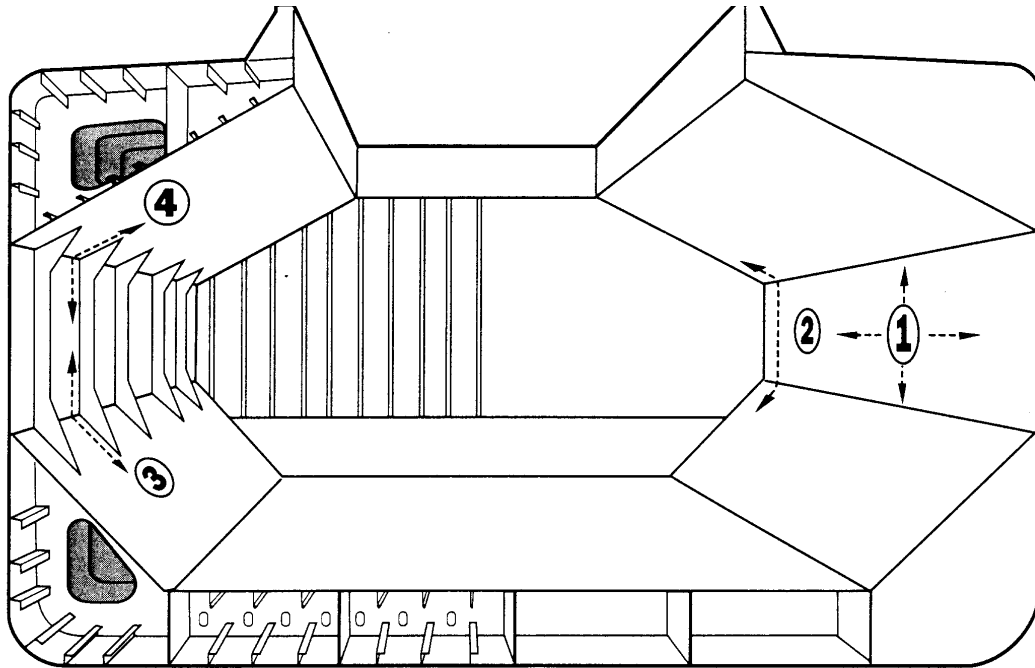
Typical cross section of bulk carrier through cargo hold.

① Side shell plating.	Cracks in welds or plates. Leaks in welds or plates. Distortion of plating.
② Connection of bulkhead plating to side shell.	Punctured plating. Cracked plating. Heavily indented plating. Buckled plating. Corrosion and wastage.
③ Connection of side shell frames and end brackets to the shell plating and hopper side tank plating by close-up inspection.	Cracks. Corrosion and wastage. Excessively deformed frames or brackets. Detached frames or brackets.
④ Connection of side shell frames and end brackets to the shell plating and topside tank plating.	Cracks. Corrosion and wastage. Excessively deformed frames or brackets. Detached frames or brackets.
