IMO

A 20/Res.866
29 December 1997
Original: ENGLISH

RESOLUTION A.866(20)
adopted on 27 November 1997

**GUIDANCE TO SHIPS' CREWS AND TERMINAL PERSONNEL FOR BULK
CARRIER INSPECTIONS**

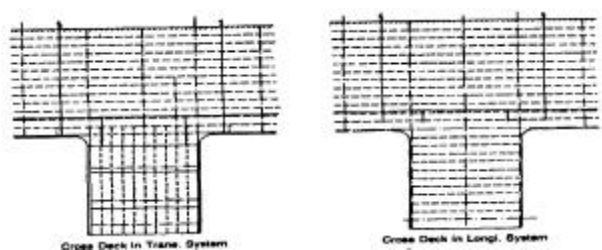
Figure 5: Comparison of stiffening systems for cross deck

Buckling of cross deck strips

6.1.4 Generally, longitudinal beams are arranged under the longitudinally continuous upper deck outboard of the side lines of the cargo hatchways. This is called the longitudinal system. When the deck beams for cross deck strips are also arranged in this manner, buckling of the cross deck strips may take place due to insufficient strength against the axial forces acting on them in a transverse direction. The transverse system is the preferred method of construction for cross deck members. Particular attention should be given to buckling of the main deck on those ships where the cross deck strips are arranged in the longitudinal system.
